Manhole Inspection Summary

Manhole # S45E__023MH

Insp Date: **7/22/08 10:52 AM**

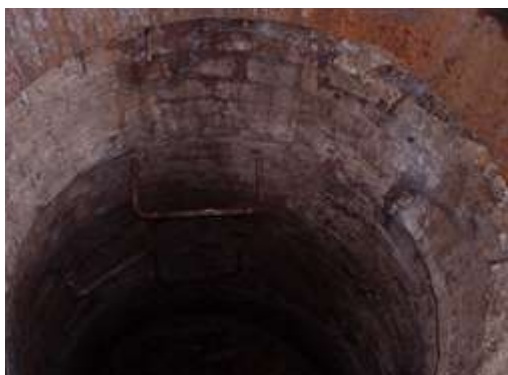
Defect 2

Infiltration: ☐ None ☒ **Joint** ☐ Cracks ☒ **Mortar** ☐ Roots ☐ Wall

Infiltration: ☐ None ☐ Joint ☐ Cracks ☐ Mortar ☐ Roots ☒ **Wall**

Infiltration

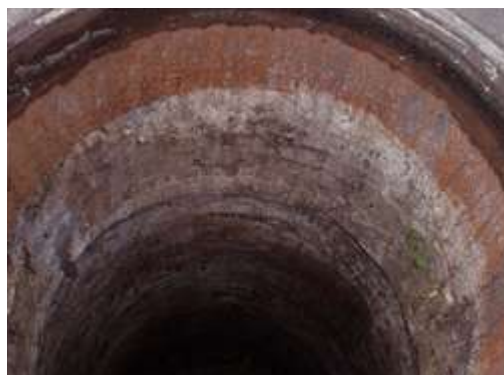
Defect 1

☒ **Leaks**

Frame Leaks

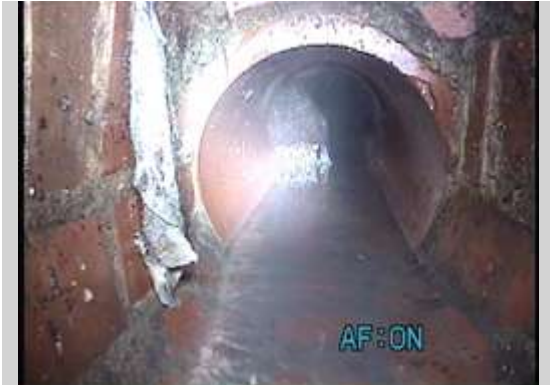
12 O'Clock Outflow

8 in. Circular Gravity Sewer
Pipe Out @ 12 O'Clock

Pipe Height: **8.4** (in.) Rod and Bar (Angled)
Pipe Material: **Clay** ☐ Pipe Lined
Invert Depth: **9.90** (ft.) Flow Characteristics: **Slow**
Deposits: ☒ None ☐ Mud ☐ Sludge ☐ Debris ☐ Grease
Silt Depth: (in.) Deposits Extent:
Infiltration: **None** Pipe Seal Cond: **Sound**

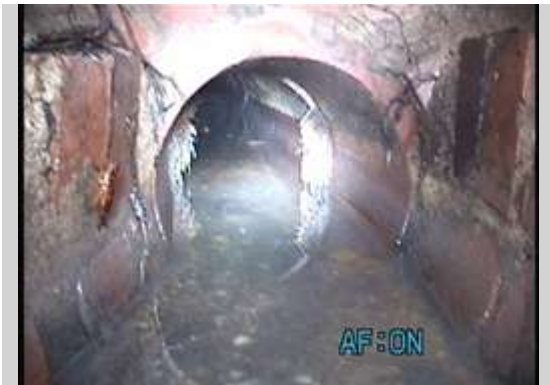
3 O'Clock Inflow

8 in. Circular Gravity Sewer
Pipe In @ 3 O'Clock

Pipe Height: **8.4** (in.) Rod and Bar (Angled)
Pipe Material: **Clay** ☐ Pipe Lined
Invert Depth: **9.85** (ft.) Flow Characteristics: **Slow**
Deposits: ☒ None ☐ Mud ☐ Sludge ☐ Debris ☐ Grease
Silt Depth: (in.) Deposits Extent:
Infiltration: **None** Pipe Seal Cond: **Sound**

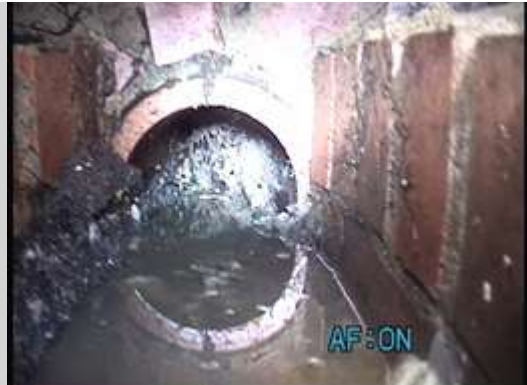
6 O'Clock Inflow

6 in. Circular Gravity Sewer

Pipe In @ 6 O'Clock

Infiltration: **None**

Pipe Seal Cond: **Sound**
